Adjusting bathing platform linear drives

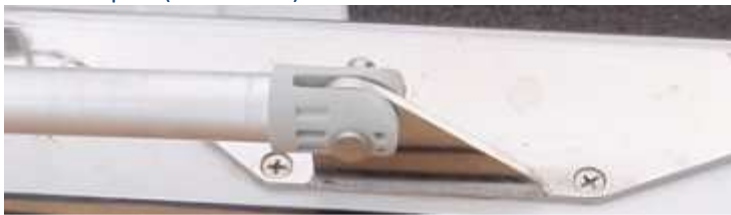
- 1 Take the rings and the bolts out of the outer ends of the drive while the platform is open (horizontal).

- 2 Push the button to let the drives completely go out until they get stopped by the end shut off.
- 3 Turn the thinner end rods clockwise (in) or anticlockwise (out) until the bolts fit freely into their holes at the fittings on top of the bathing platform.
- 4 If there is not enough way you can also adjust the distance on the other end where the electric drives are connected to the cockpit floor.
- 5 Put the bolts and rings back and make sure the bolts can be moved sideways without resistance (free play).
